A Detailed Conservation Report of a Heavily Retouched Painting from the Otto Valstad Collection

Masteroppgave in Malerikonservering

Institute for arkeologi, konservering og historie

Virgin and child with St Elizabeth and infant St John the Baptist, in a landscape – Asker Museum

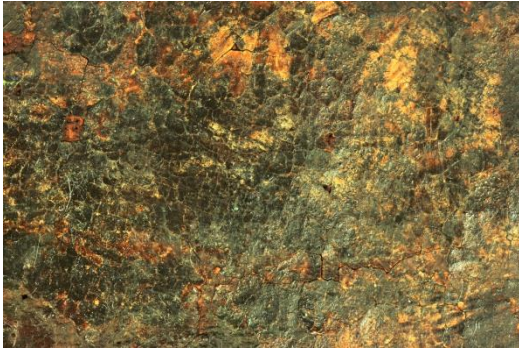
Img 15 Visible filler material, found in the tree 01

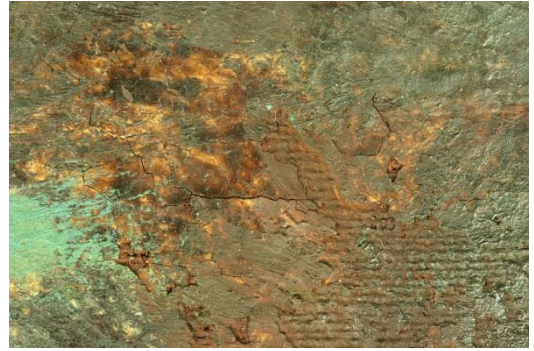
Img 16 Visible filler material, found in the tree 02

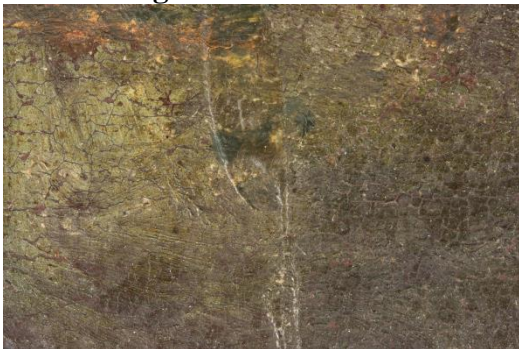
The surface dirt of this painting was not examined with regards to its exact components. It was only merely observed to the point of confirming its existence, through visual investigations and cleaning tests. Its components were estimated through personal communication with Asker Museum, with regards to known activities that existed throughout the room where the painting is currently displayed. A wax substance was visually observed on the painting, yet due to time restraints this material was not further investigated upon as it was most likely from a candle that at one point in time had dripped on the painting (Img 19).

Img 19 Wax drip, found on the painting over the varnish

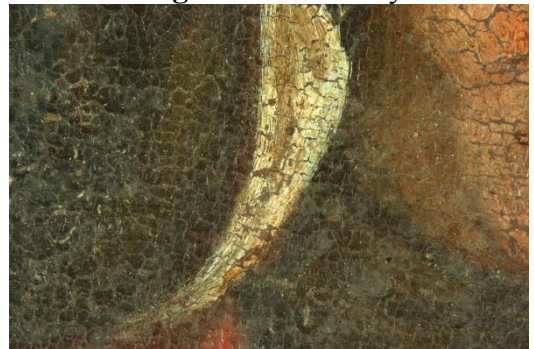
Img 20 Yellowing of the varnish seen in the white areas of the of the painting

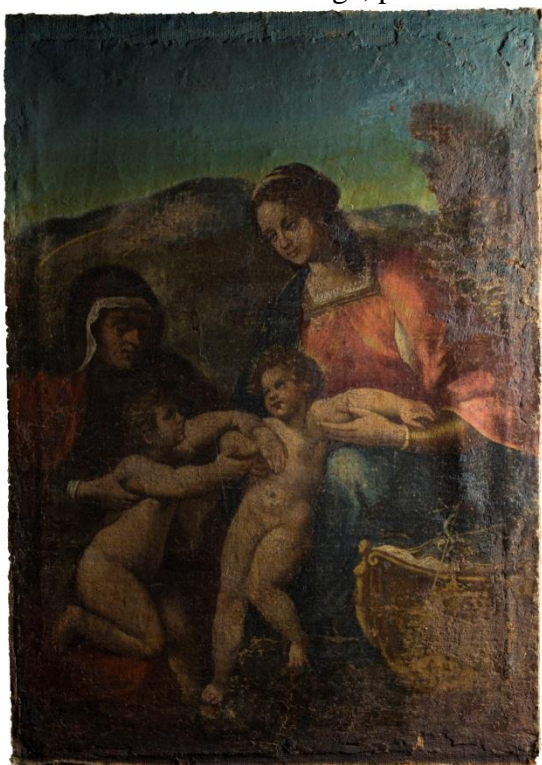
Both the original and secondary canvases' condition were also investigated by transillumination and raking light. Transillumination and raking light are considered two ways of examining a painting using different types of light. Transillumination (Imgs 23 & 24) involves the light being placed behind the painting where the light will shine easily through weakened canvas areas or where paint loss is apparent. Raking light (Img 25) involves the light being omitted from the side of the painting rendering deformations in the canvas more easily assessable. The later method especially was significant in analyzing the condition of the previous lining (Imgs 25 & 26).

Img 25 Raking light image of the painting, still attached to the lining

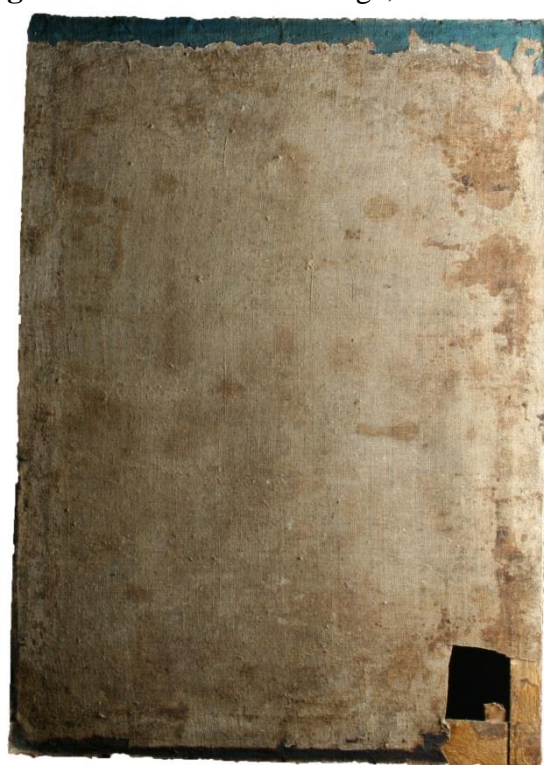
Img 26 Raking light image of the lining canvas

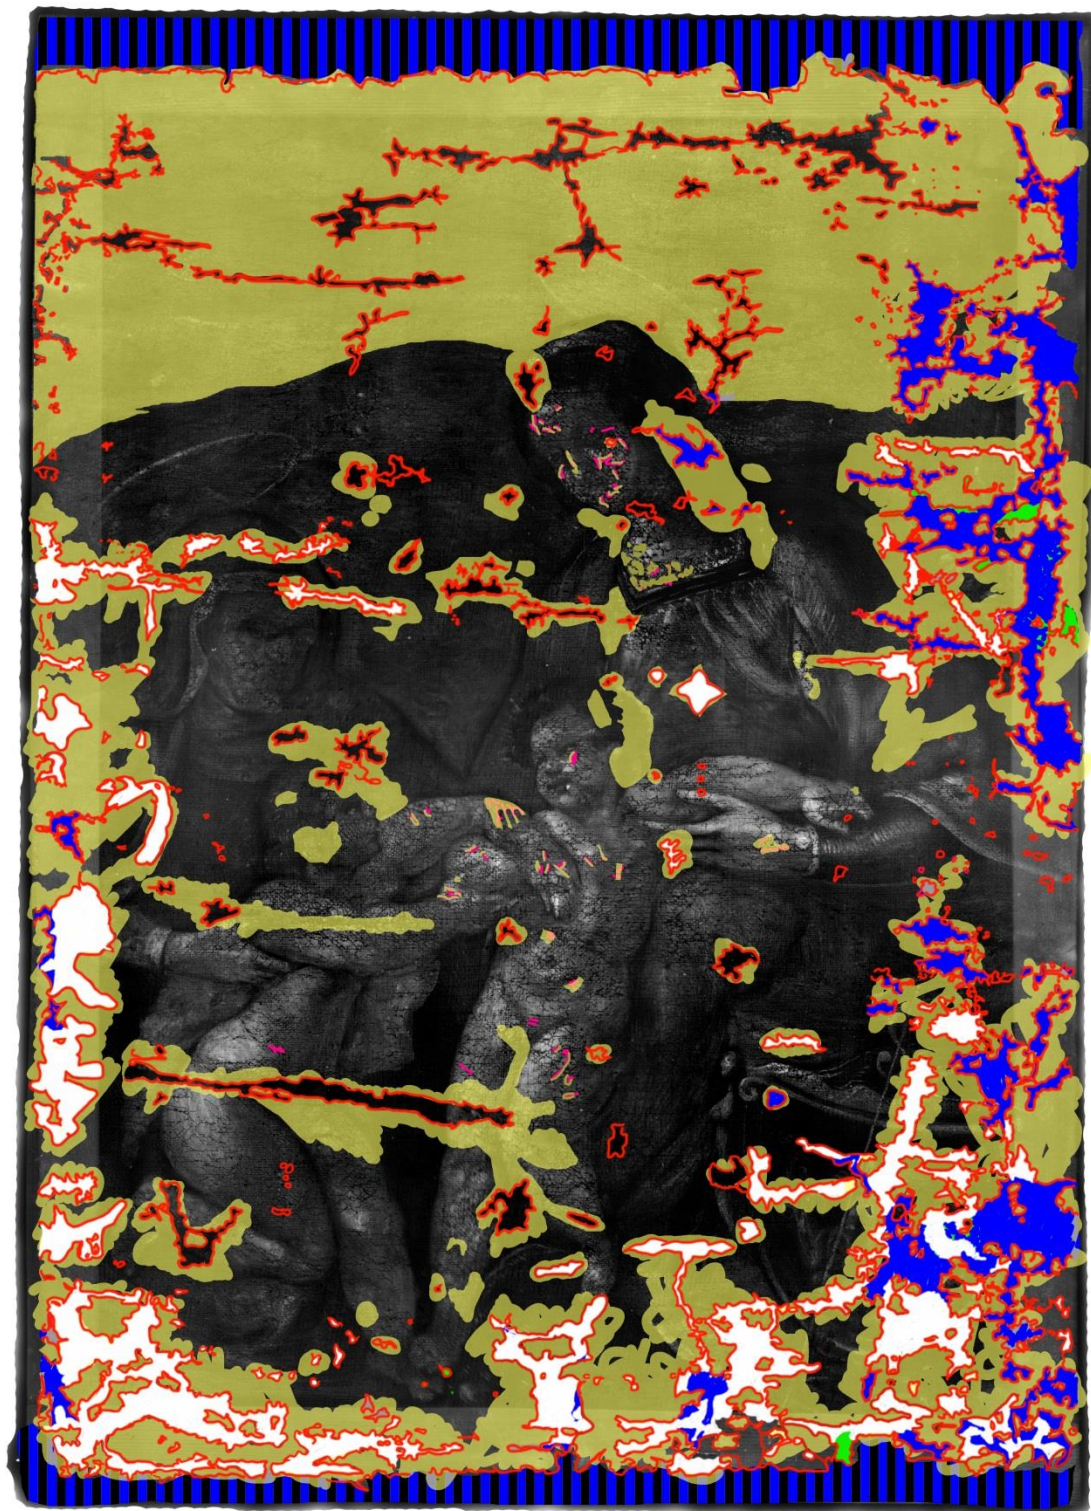
The localization of secondary paint⁶ and filler material were registered (Imgs 27-35). They were best observed using comparative investigations of visual analysis together with photo-analytical methods such as x-ray, UV, and IR (Appendix 1 Fig 1.2-1.6). Their localization was important to establish prior to cleaning in order to ensure that cleaning in the 2013/2014 treatment would be proceeded upon ethically and their removal heavily considered. X-ray especially (Appendix 1 Fig 1.2), as well as removability tests, made it possible to observe a large overpainting found throughout the entire sky in the motif. X-ray provided significant information regarding the existence of intact original paint observed beneath

Img 27 Overview of loss, overpaint, retouches, and visible filler material, prior to treatment

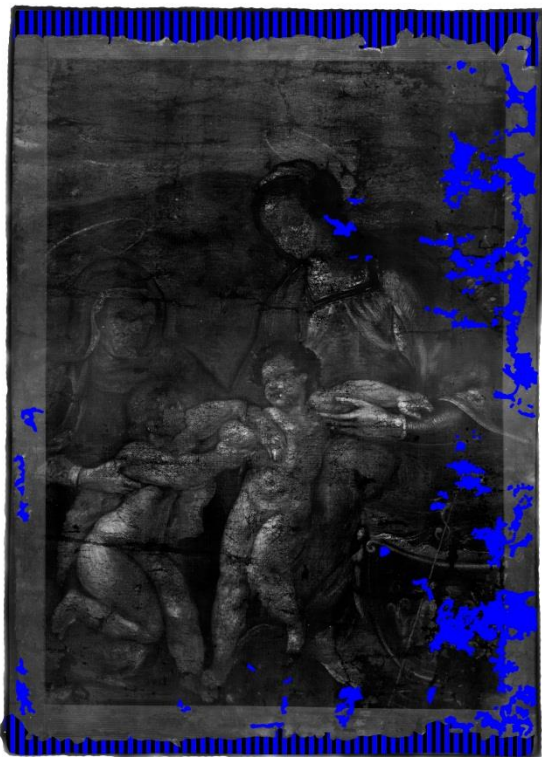
Img 28 Areas of retouching, directly on canvas

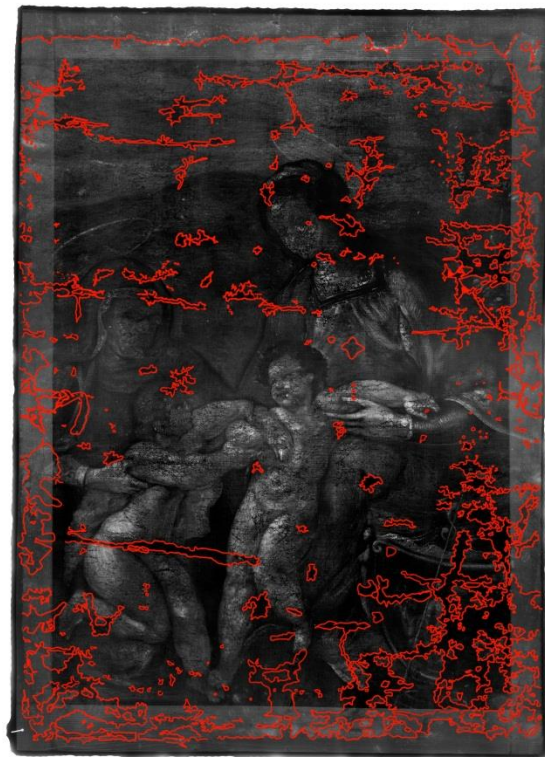
Img 29 Losses located within the painting

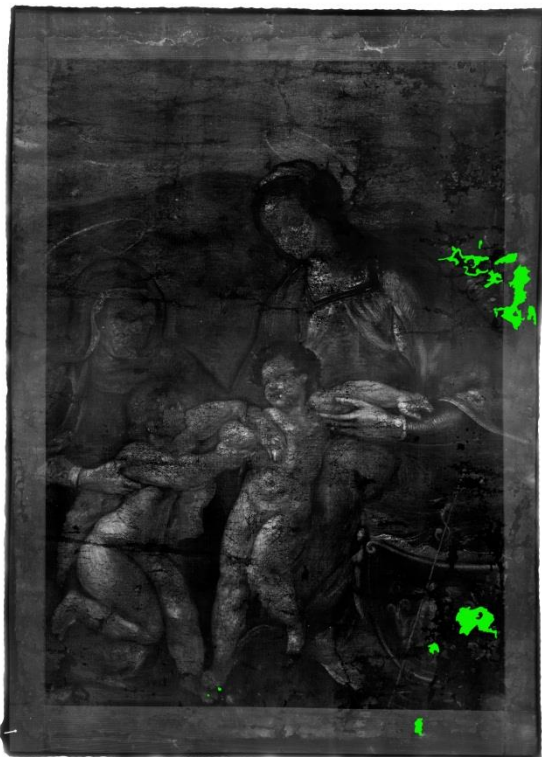
Img 30 Areas of bare original canvas, not covered by secondary paint

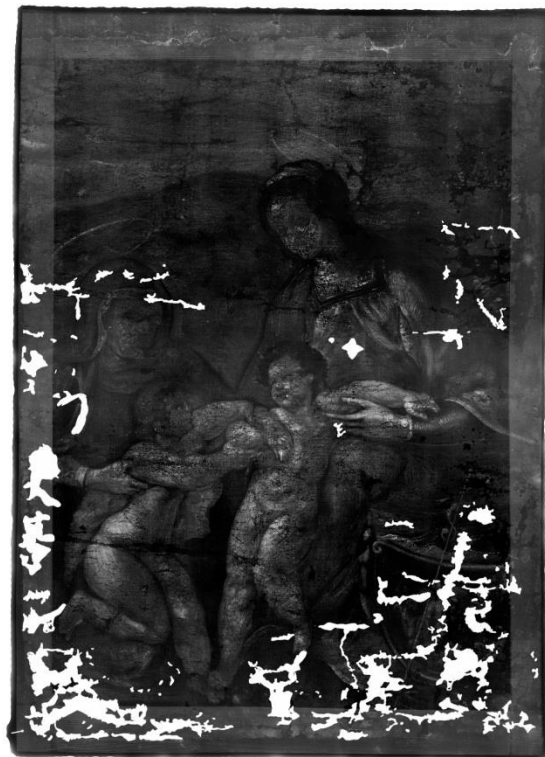
Img 31 Visible filler material prior to treatment (more were later found in the overpainted sky)

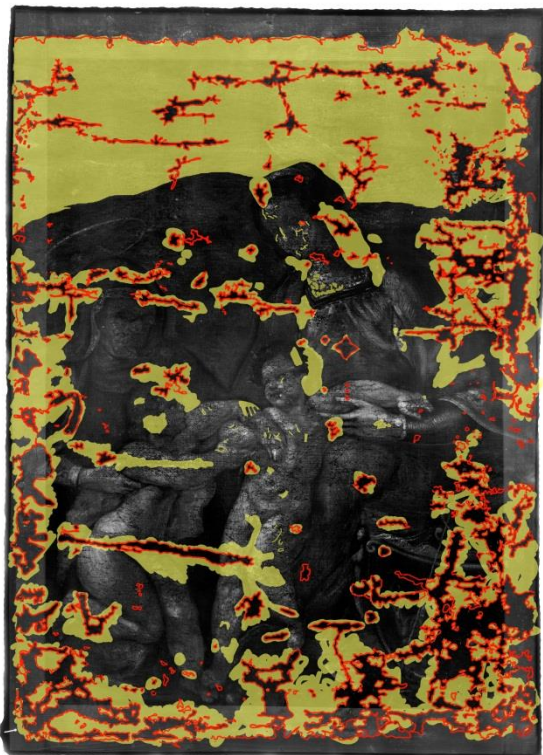
Img 32 Overpaint on original, prior to 2013/2014 treatment

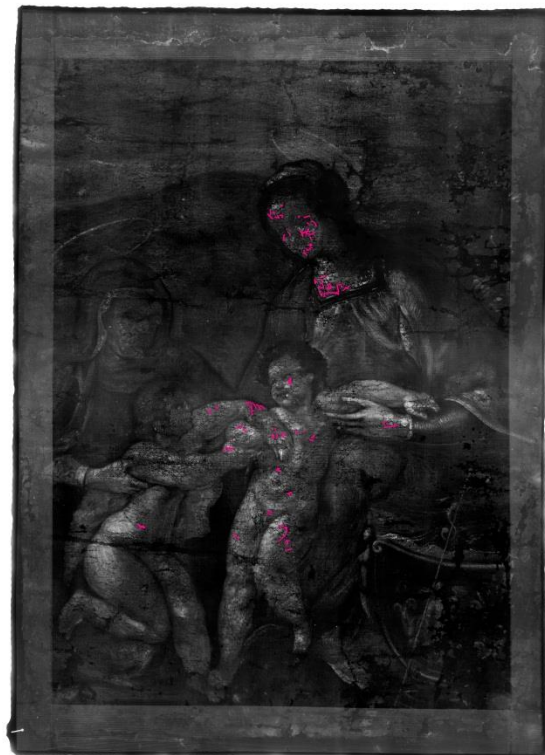
Img 33 Overpaint on ground

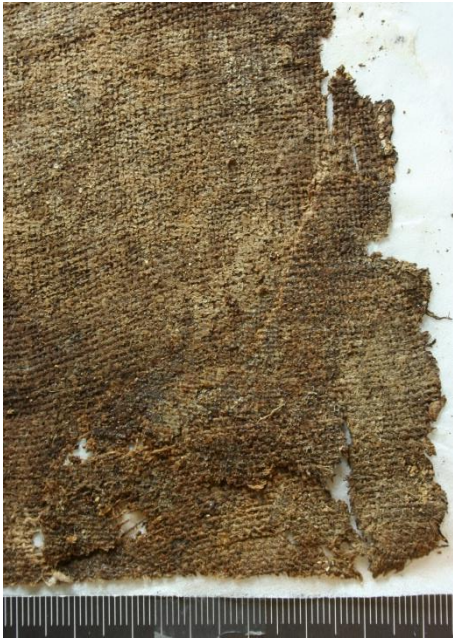
Img 40 wear and tear along the edges of the original canvas 1

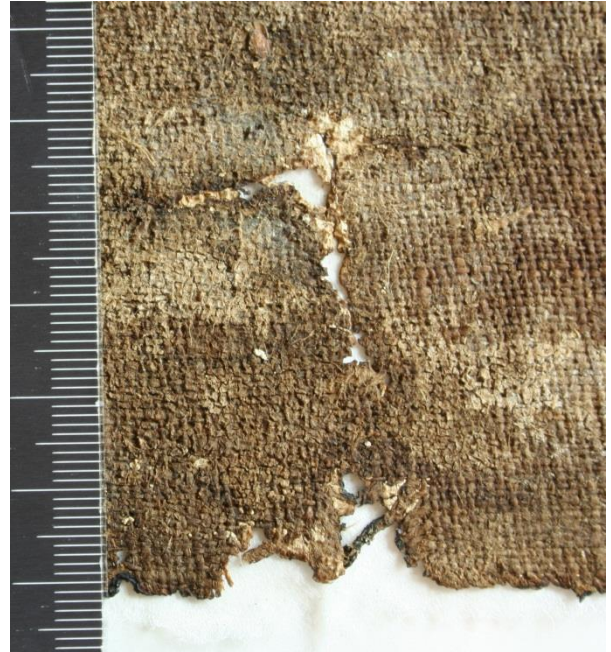
Img 41 wear and tear along the edges of the original canvas 2

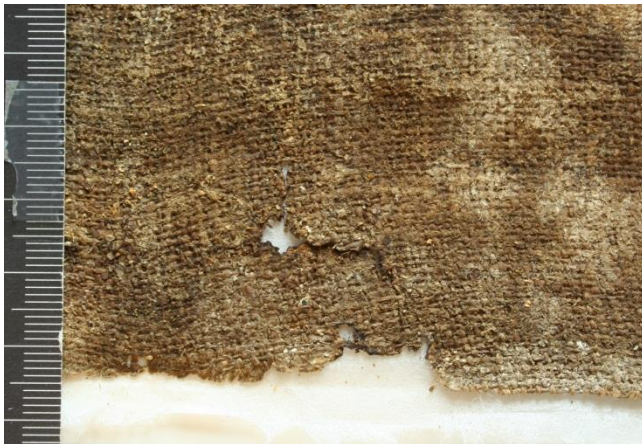
Img 42 wear and tear along the edges of the original canvas 3

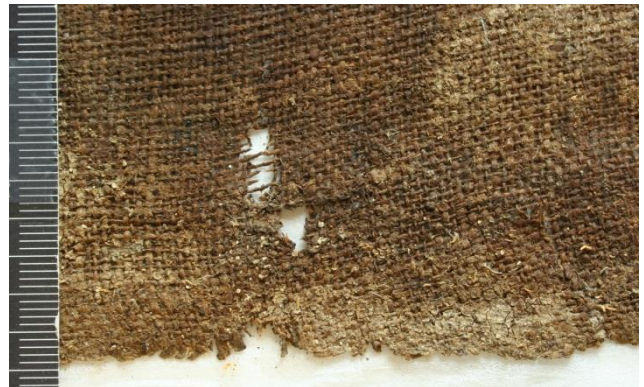
Img 43 wear and tear along the edges of the original canvas 4

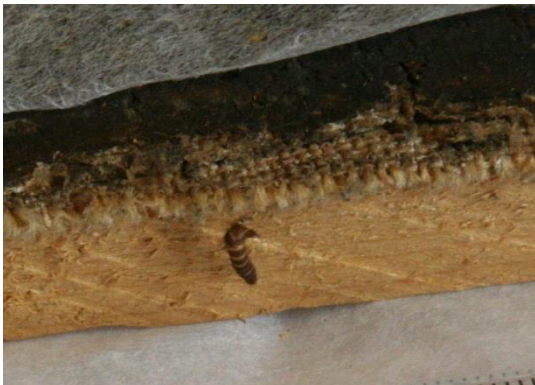
Img 44 dead insects found after the removal of the painting from its decorative frame 1

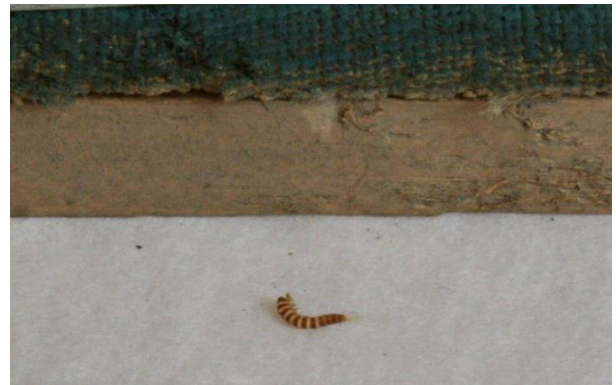
Img 45 dead insects found after the removal of the painting from its decorative frame 2

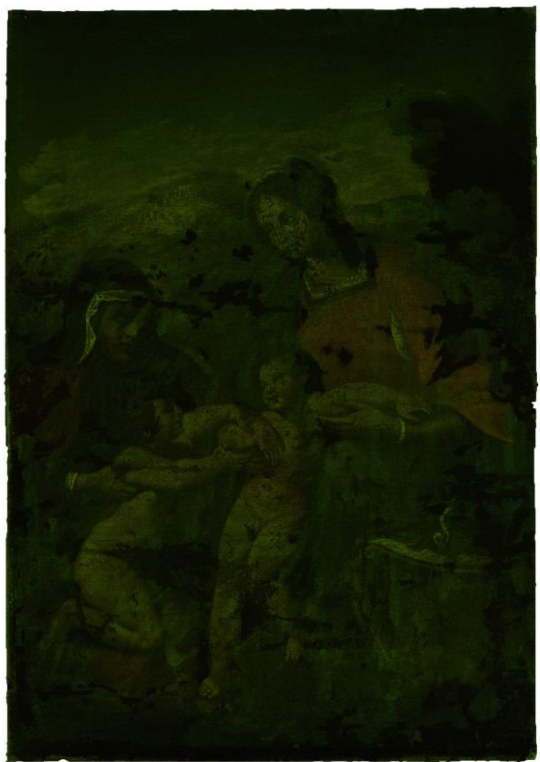
The condition of the varnish was best observed by the naked eye in visible light and under UV (Appendix 1 Fig 1.3-1.4). This is because the varnish layer becomes darker, more yellow, and more obscure within a few decades of application (Phenix and Wolbers 2012:524). This yellowing of the varnish in visible light was best observed in areas of the original paint layers that were recognized as white (Img 20). UV was helpful in understanding the deterioration of the varnish layers since, as the varnish ages it appears more opaque (de la Rie 1982:2). This is important to know since, varnishes that are more aged can at times be more difficult to remove (Phenix and Wolbers 2012:530-531) as they require more polar solvents. Therefore, removal testing was also a method executed of assessing its condition.

Fig 1.3 UV image, prior to investigations and treatment
